Ontario Clean Water Agency  
901 Main Street,  
Geraldton (Ontario) P0T 1M0

February 10, 2021

RE: Designated Substances Survey  
Wastewater Treatment Plants  
Longlac and Nakina, Ontario

DST File No.: 02100047.000

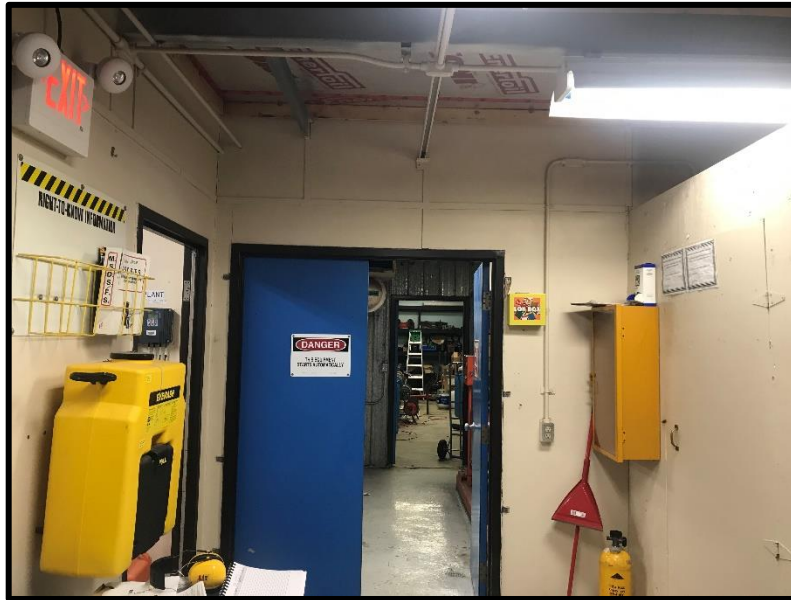
- Transite cement board, sampled from the walls of the entrance way, the adjacent office, bathroom and boiler room of the Wastewater Treatment Plant (Longlac), contains 15% chrysotile asbestos (Sample L-1A). Approximately 85m<sup>2</sup> of transite was observed.

**Photograph 1:** Entrance way (Wastewater Treatment Plant - Longlac)  
Asbestos-Containing transite board (Sample L1A-C).

- Removal of non-friable transite and vinyl floor tiles with suspected asbestos-containing associated mastic can be conducted utilizing Type 1 asbestos precautionary measures as

per O.Reg. 278/05, as amended, provided the material is wetted to control the spread of dust or fibres, and the work is done only by means of non-powered hand-held tools. If these conditions cannot be met, then more stringent (Type 2 or Type 3) work procedures are required (e.g. power tool removal).

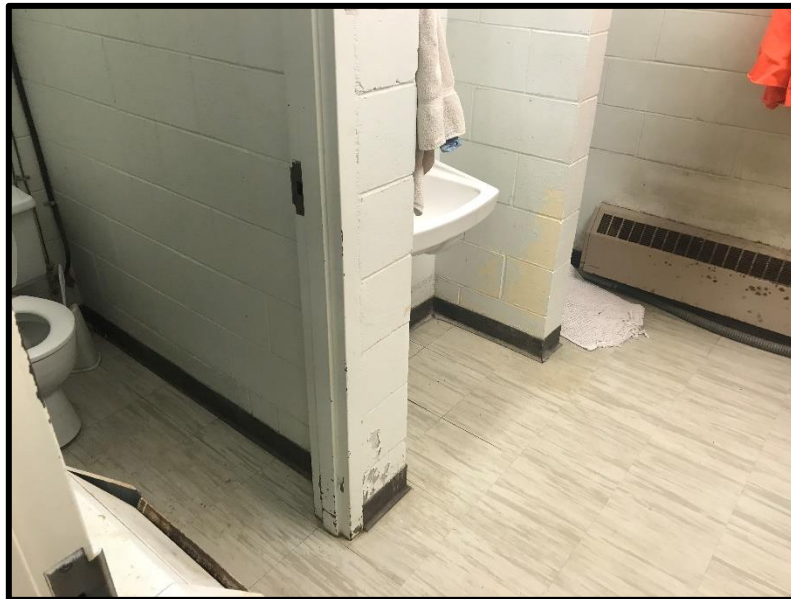
- 12" x 12" vinyl floor tile, beige, sampled in the bathroom of the Water Treatment Plant (Nakina), contains 2% Chrysotile asbestos (Sample N2A). Approximately 10m<sup>2</sup> of vinyl floor tile was observed in the bathroom. Associated black mastic shall be considered asbestos containing unless further sampling proves otherwise.

**Photograph 2:** Bathroom (Water Treatment Plant - Nakina)  
Asbestos-containing vinyl floor tiles (Sample N2A-C).
